Manhole Inspection Summary

Manhole # S39UU_005MH

Insp Date: **12/19/06 10:33 AM**

Location Address: **1132 30TH ST**

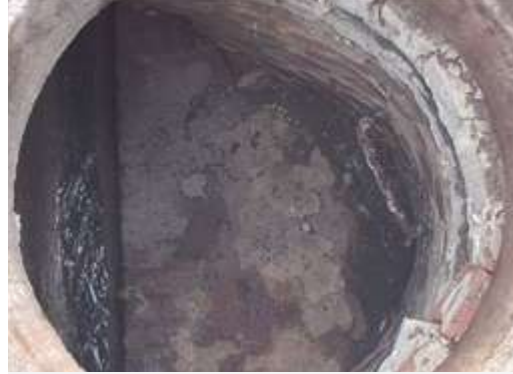
Top View

Bench ☒ Exists Material: **Brick** ☐ Parged ☒ **Debris** (not Condition related)

Steps Count: **1** Missing: **0** ☒ **Corroded**

Corroded steps. Bench debris.

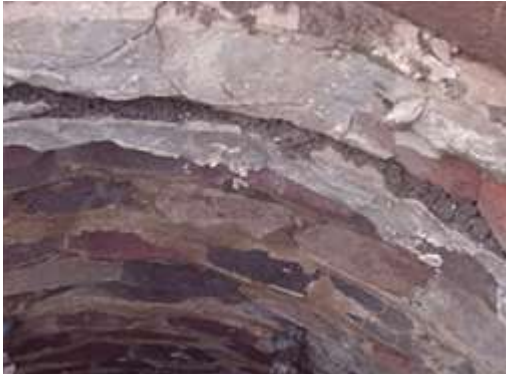
Defect

Frame Offset: **0** (in.) Condition: ☐ Sound ☐ Cracked ☒ **Leaks**

Condition: ☐ Sound ☐ Cracked ☐ Root Intrusion ☐ Loose Brick ☒ **Deteriorated**

Infiltration: ☐ None ☒ **Joint** ☐ Cracks ☐ Mortar ☐ Roots ☒ **Wall**

Frame leaks. Adjustment deterioration and infiltration.

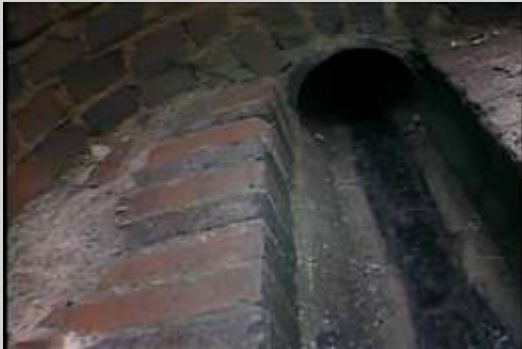
8 in. Circular Gravity Sewer Pipe Out @ 12 O'Clock

Infiltration: **Evidence** Pipe Seal Cond: **Unknown**

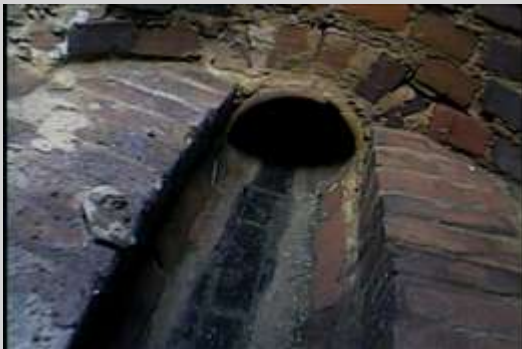
8 in. Circular Gravity Sewer Pipe In @ 6 O'Clock

Condition: ☐ Sound ☐ Cracked ☐ Root Intrusion ☐ Loose Brick ☒ **Deteriorated**

Infiltration: ☐ None ☐ Joint ☐ Cracks ☒ **Mortar** ☐ Roots ☐ Wall

Barrel deterioration and infiltration.

Infiltration: **None** Pipe Seal Cond: **Broken**
